Arborist Report 4217 Oakwood Drive

This Tree Risk Assessment was requested on May 20, 2025, by James Hartley, the property owner at 4217 Oakwood Drive in Anytown, Florida. The assessment was conducted on May 29, 2025, by John Snow, a Board Certified Master Arborist (BCMA, TRAQ). The purpose of the evaluation was to assess the risk posed by one primary Bald Cypress tree on the neighboring property to the left, and by nearby trees, following storm impacts. The adjoining property owner permitted access to complete the 360-degree inspection.

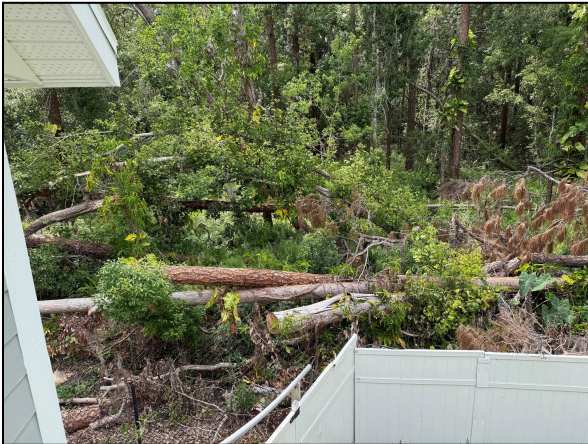
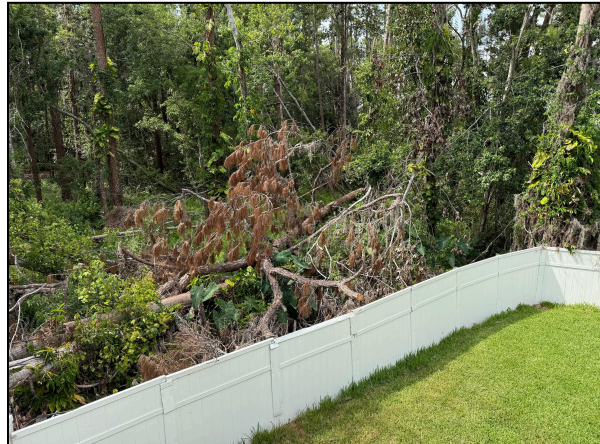
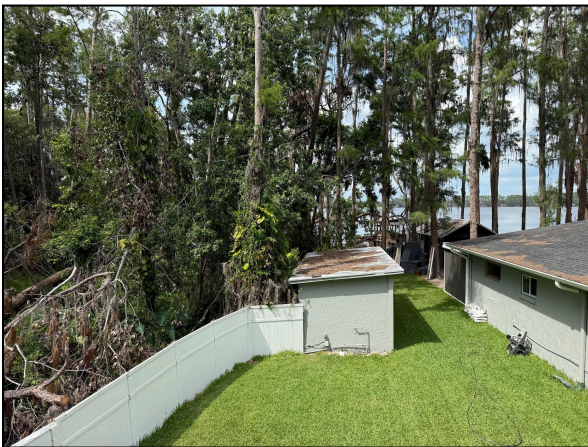
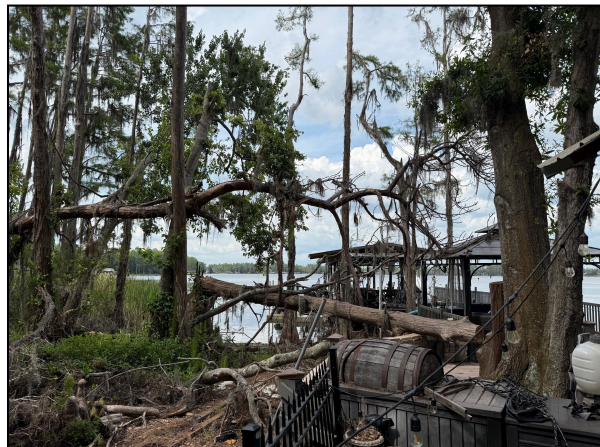
Several nearby trees have previously failed, including adjacent Slash Pines (*Pinus elliottii*) and another Bald Cypress. The fallen Pines are physically pressing against the subject Cypress tree, compounding its lean and mechanical loading. The subject tree also has increased canopy exposure due to the loss of surrounding trees, which elevates its susceptibility to wind.

Photos of Previous Damage to Nearby Trees Post-Milton

The most effective mitigation measure is the removal of the subject Bald Cypress tree before the onset of Florida's wet season in July. Pruning or monitoring will not sufficiently reduce risk. Removal may require tree climbing and rigging due to poor access and damp ground conditions. Speed-lining to a safe zone may be required. One adjacent cypress tree also presents a potential risk and is recommended for removal.

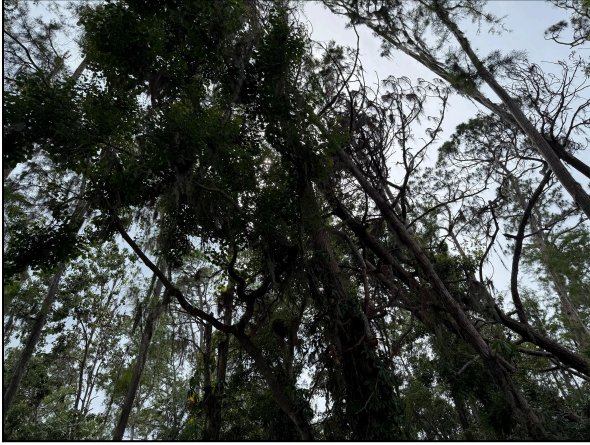
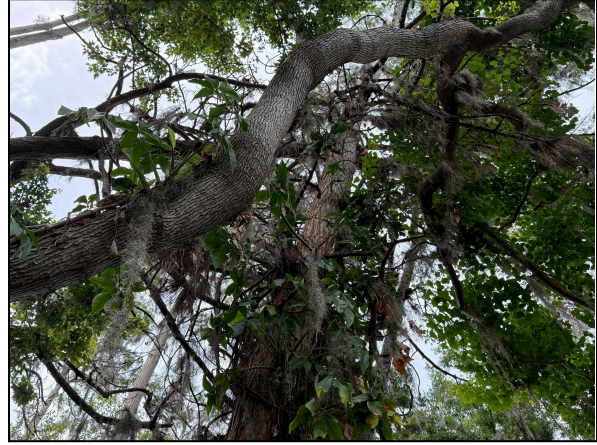
The subject Bald Cypress tree shows clear structural stress. There is evidence of soil movement around the base, suggesting the root plate has shifted several feet. The lean, compounded by pressure from adjacent fallen Pines and exposure changes, presents significant concern. Based on its height and distance from the home, it would strike the residence or outdoor structures if it failed in its current condition.

Adjacent Pines Against Subject Cypress Tree

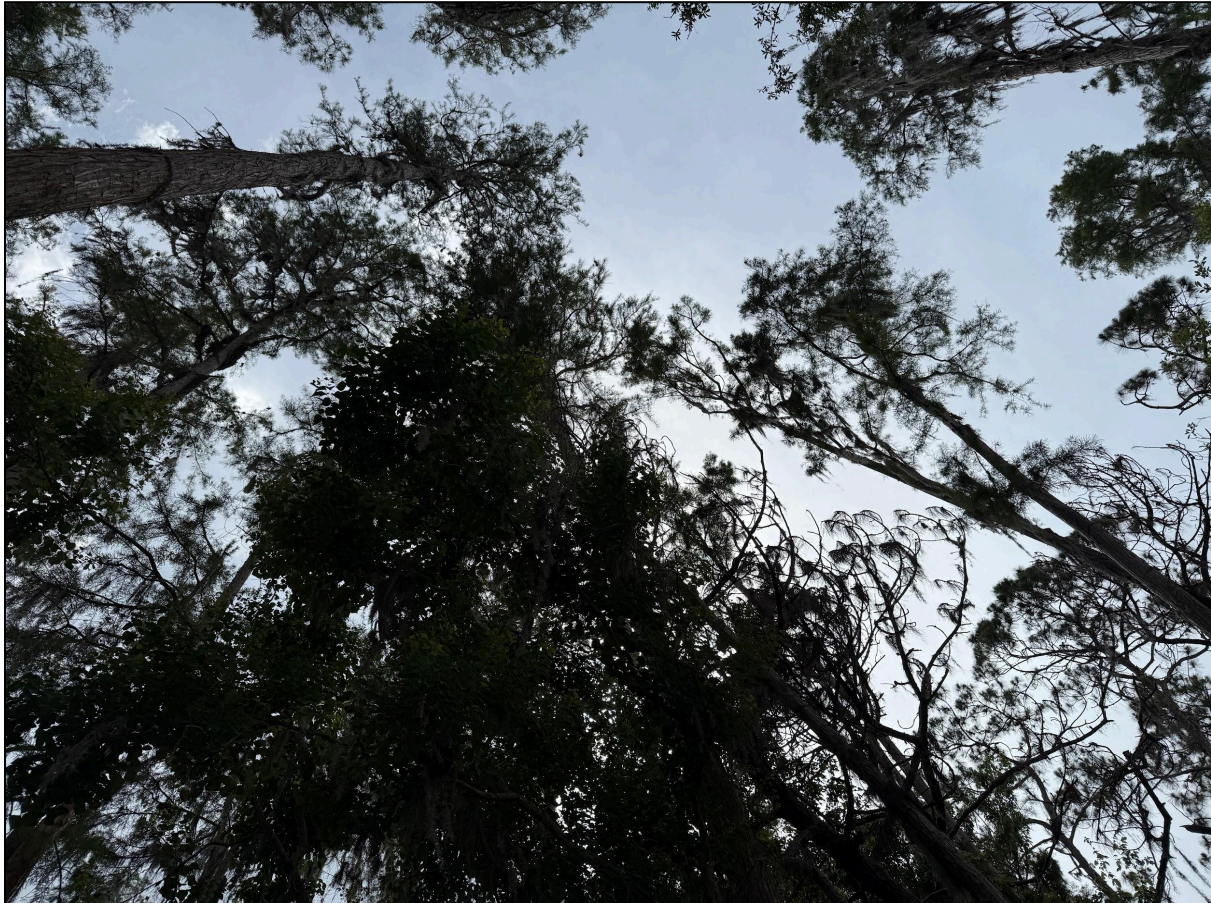
- **Species:** Bald Cypress (*Taxodium distichum*)
- **Diameter at Breast Height (DBH):** 22 inches
- **Estimated Height:** ~109 feet
- **Distance to Structures:** 24 feet from the rear fence; 47 feet from the home
- **Notable Condition:** Exhibits a ~30° lean toward the residence, with visible soil displacement at the root plate

Overall Tree Lean

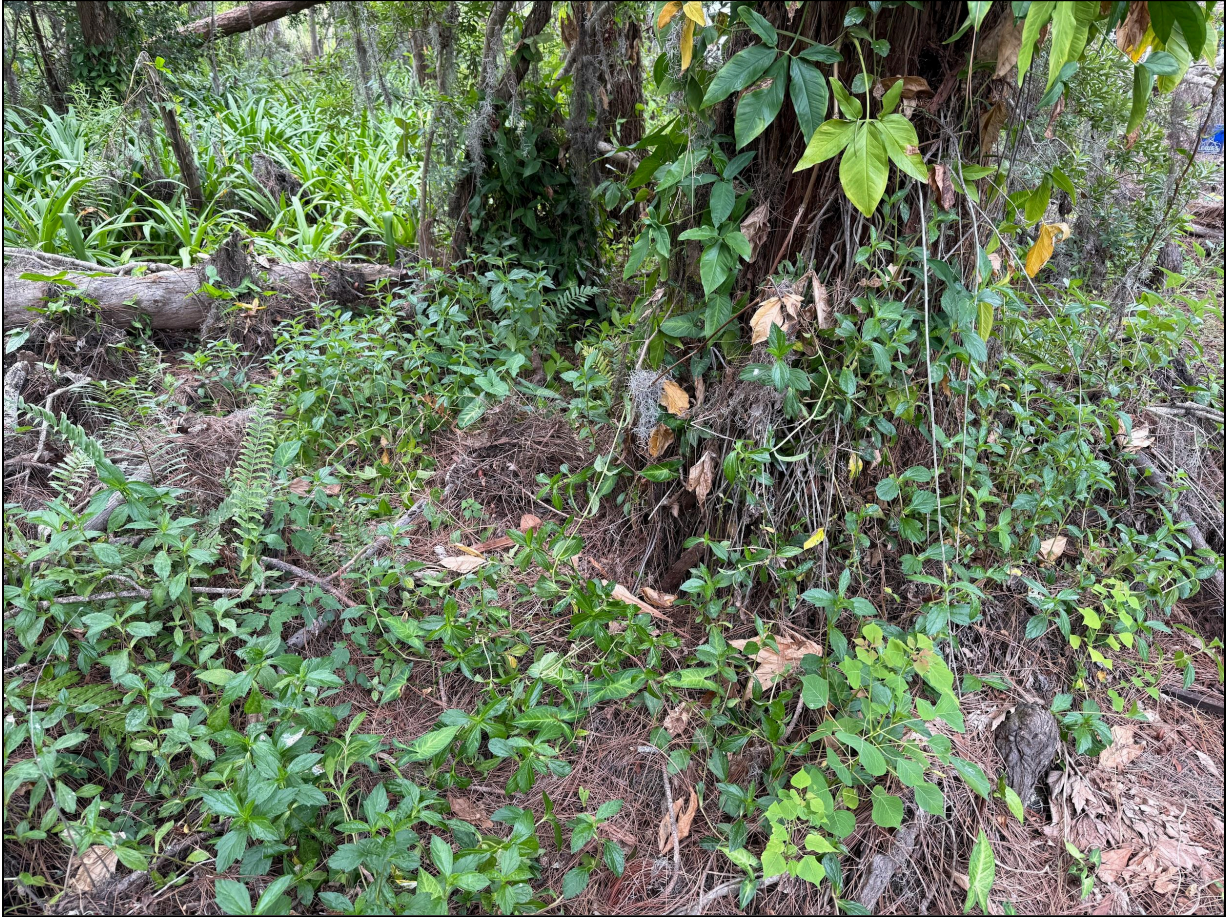
The tree is located adjacent to a seasonal drainage ditch that is wet for much of the year, further increasing risk due to saturated soil conditions.

Compromised Root Zone Area
