Arborist Report 4217 Oakwood Drive

This Tree Risk Assessment was requested on May 20, 2025, by James Hartley, the property owner at 4217 Oakwood Drive in Anytown, Florida. The assessment was conducted on May 29, 2025, by John Snow, a Board Certified Master Arborist (BCMA, TRAQ). The purpose of the evaluation was to assess the risk posed by one primary Bald Cypress tree on the neighboring property to the left, and by nearby trees, following storm impacts. The adjoining property owner permitted access to complete the 360-degree inspection.

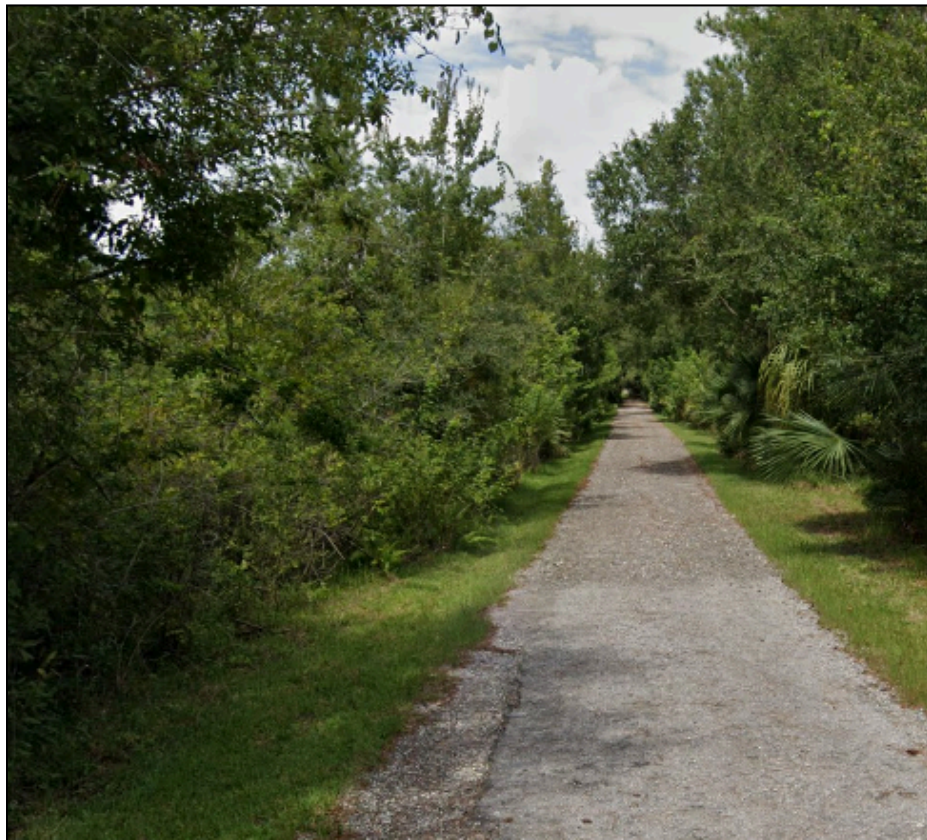
- **Species:** Bald Cypress (*Taxodium distichum*)
- **Diameter at Breast Height (DBH):** 22 inches
- **Estimated Height:** ~109 feet
- **Distance to Structures:** 24 feet from the rear fence; 47 feet from the home
- **Notable Condition:** Exhibits a ~30° lean toward the residence, with visible soil displacement at the root plate

The subject Bald Cypress tree shows clear structural stress. There is evidence of soil movement around the base, suggesting the root plate has shifted several feet. The lean, compounded by pressure from adjacent fallen Pines and exposure changes, presents significant concern. Based on its height and distance from the home, it would strike the residence or outdoor structures if it failed in its current condition.

The most effective mitigation measure is the removal of the subject Bald Cypress tree before the onset of Florida's wet season in July. Pruning or monitoring will not sufficiently reduce risk. Removal may require tree climbing and rigging due to poor access and damp ground conditions. Speed-lining to a safe zone may be required. One adjacent cypress tree also presents a potential risk and is recommended for removal.
